Occurrence mechanism of rockslide at the  
time of the Chuetsu earthquake in 2004  
- A dynamic response analysis by using a  
simple cyclic loading model -

Norihiro TANAKA  
A.Wakai, S.Abe, H.Kawabata,  
M.Genda, H.Yoshimatsu

ISL 2008/7/4 Xi'an

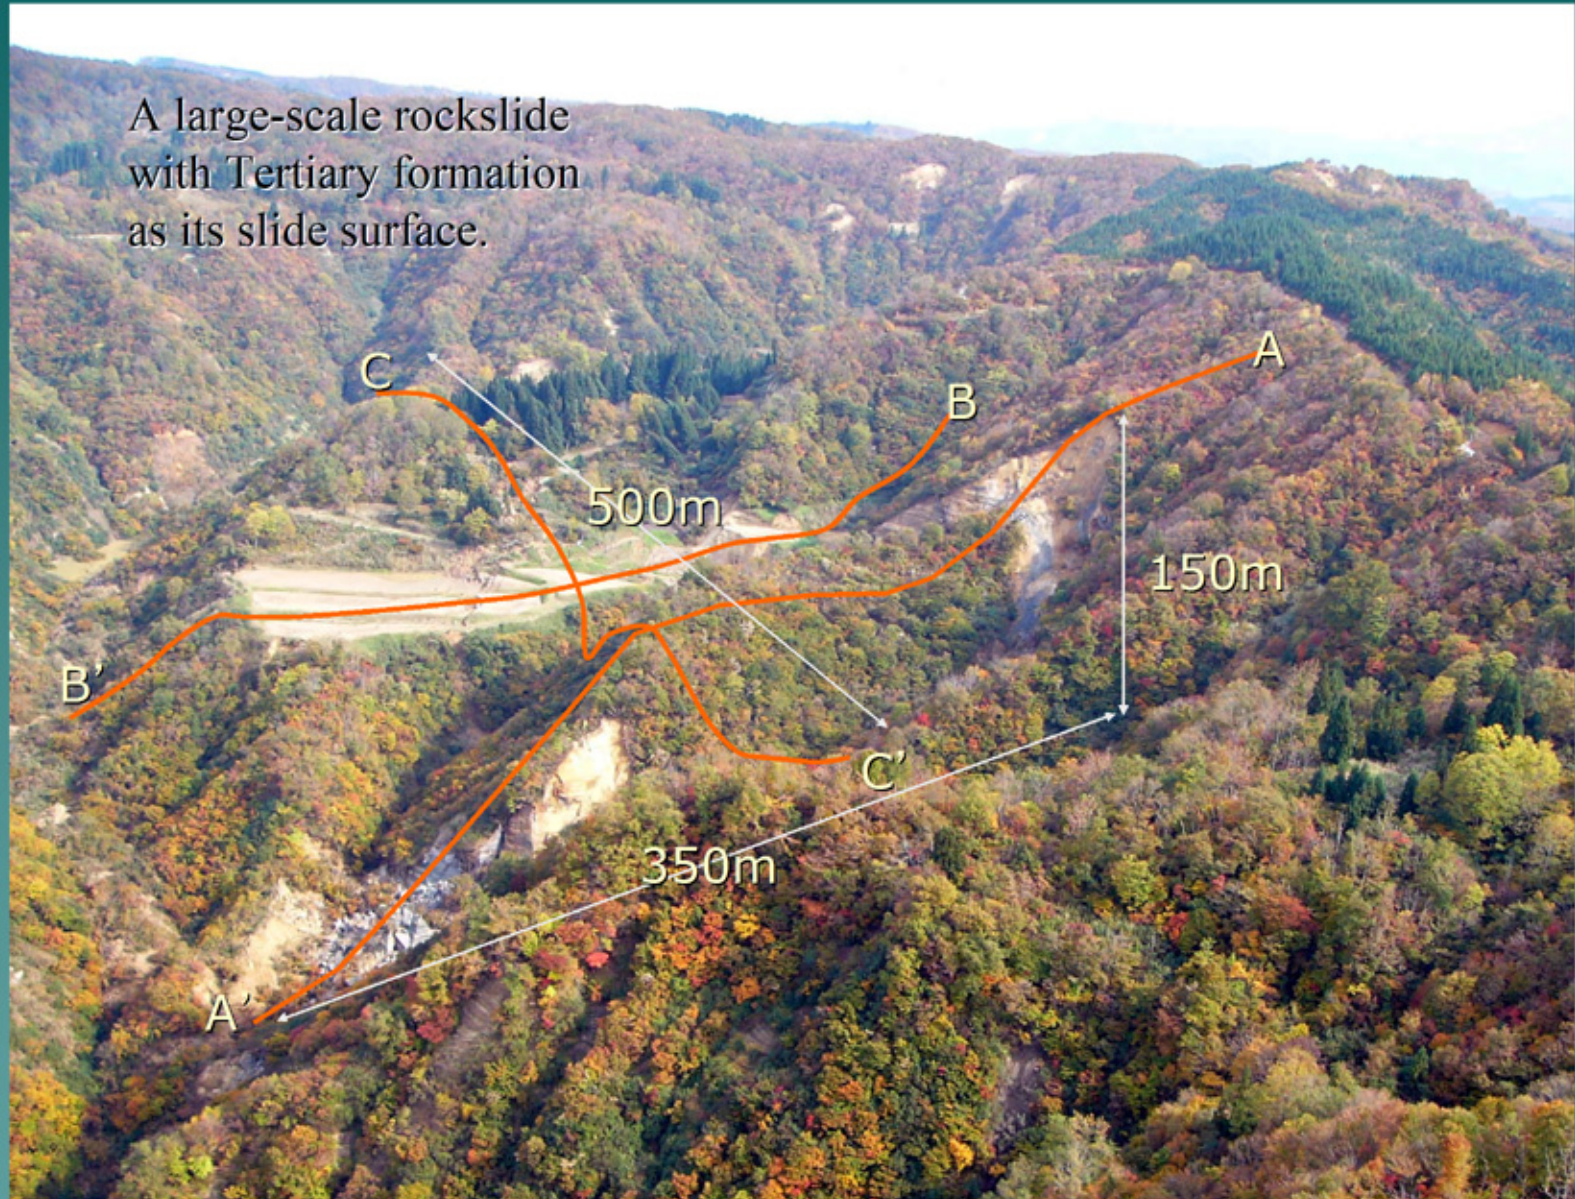
Overall view of Hitotsu-minesawa (Photo by Haraguchi, 2004)

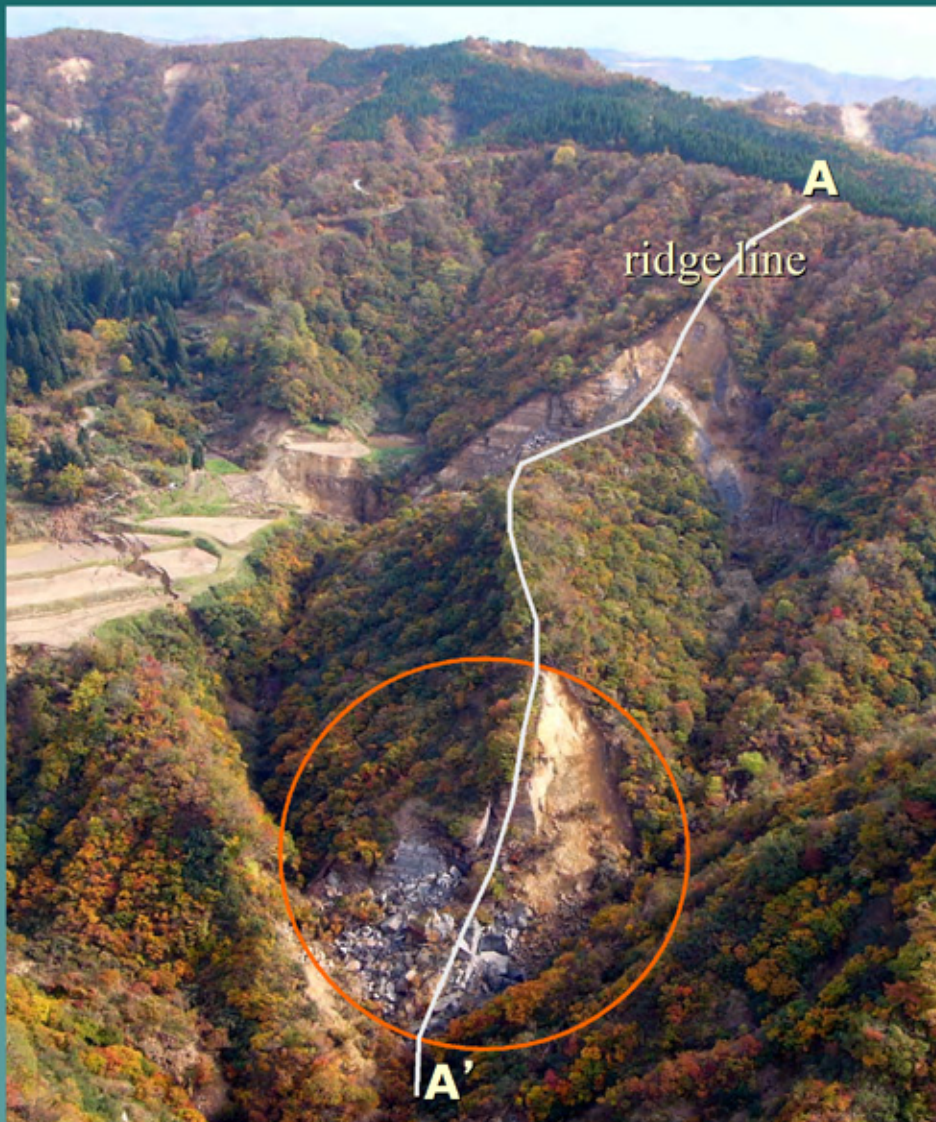
Severe fractures at the front-end of the slide

<A-A' section>

A summary by the photograph (Photo by Haraguchi, 2004)

- The fractures at the front end of the landslide body
  - Many cracks occurred in the stream
- Suggestion : Strong inertial force being at work on the slope-end.

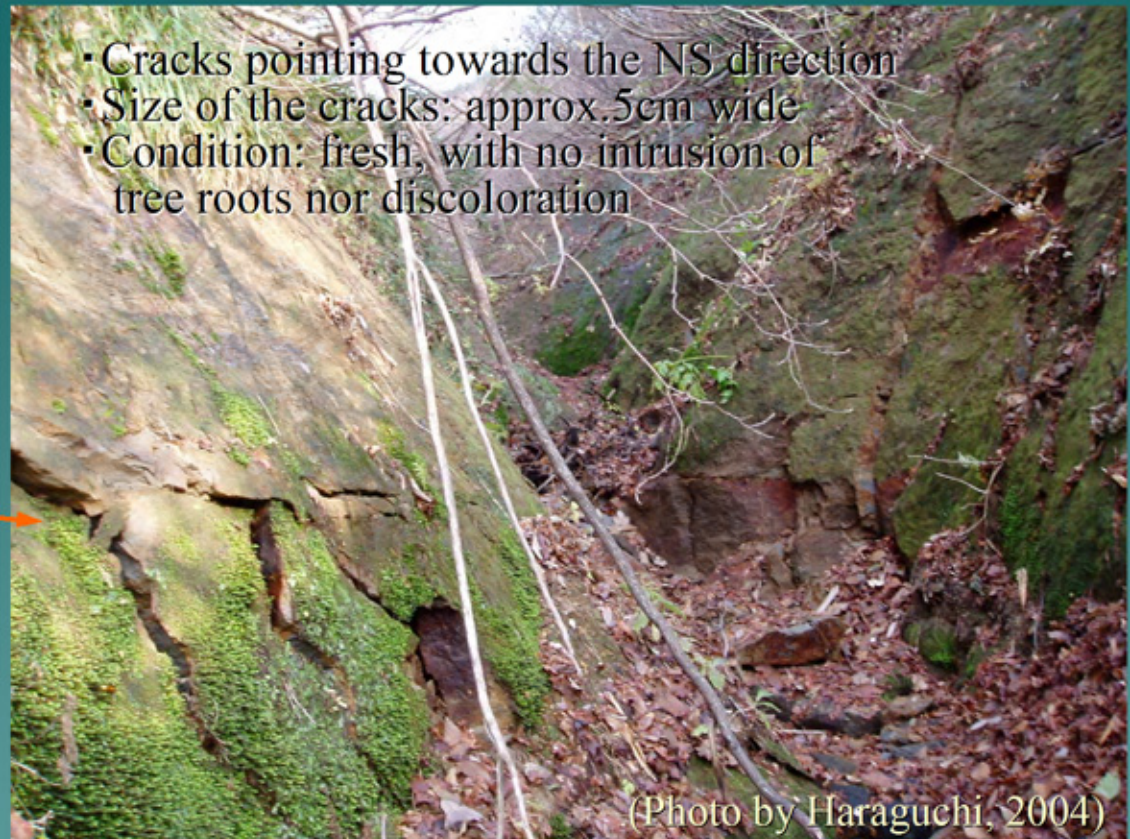
Many cracks occurred in the stream by the ridges.

(Photo by Haraguchi, 2004)
